Manhole Inspection Summary

Manhole # S29GG1023MH

Location Address: **4000 LINKWOOD RD**

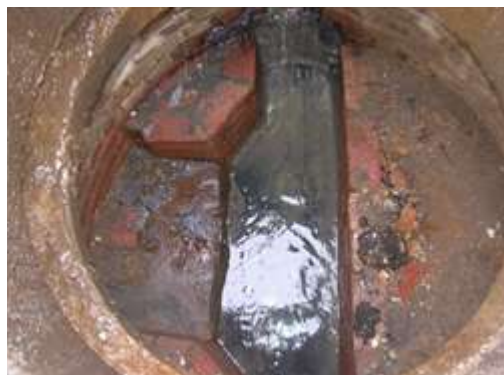
Top View

Frame leaks. Frame offset. Corbel and Barrel infiltration. Evidence of surcharge - Bench debris

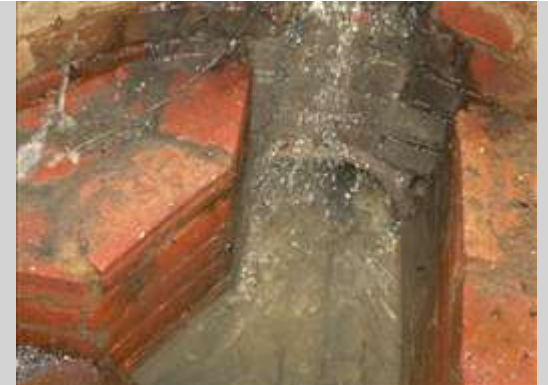
8 in. Circular Gravity Sewer Pipe Out @ 12 O'Clock

Barrel deterioration, root intrusion and infiltration.

Infiltration: **Evidence** Pipe Seal Cond: **Cracked**

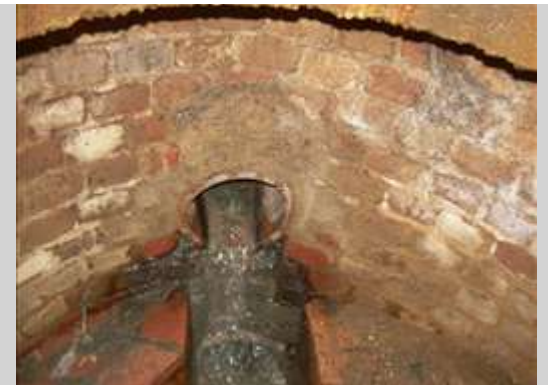
8 in. Circular Gravity Sewer Pipe In @ 12 O'Clock

Infiltration: **Evidence** Pipe Seal Cond: **Unknown**
